Technical Note

January 1986

By Spencer R. Conklin,
Daniel A. Zarate,
and Robert L. Alumbaugh
Sponsored by
Naval Facilities
Engineering Command

Experimental Polyurethane Foam (PUF) Roofing Systems- III: Naval Station, Roosevelt Roads, Puerto Rico, and Naval Facility, Cape Hatteras, North Carolina

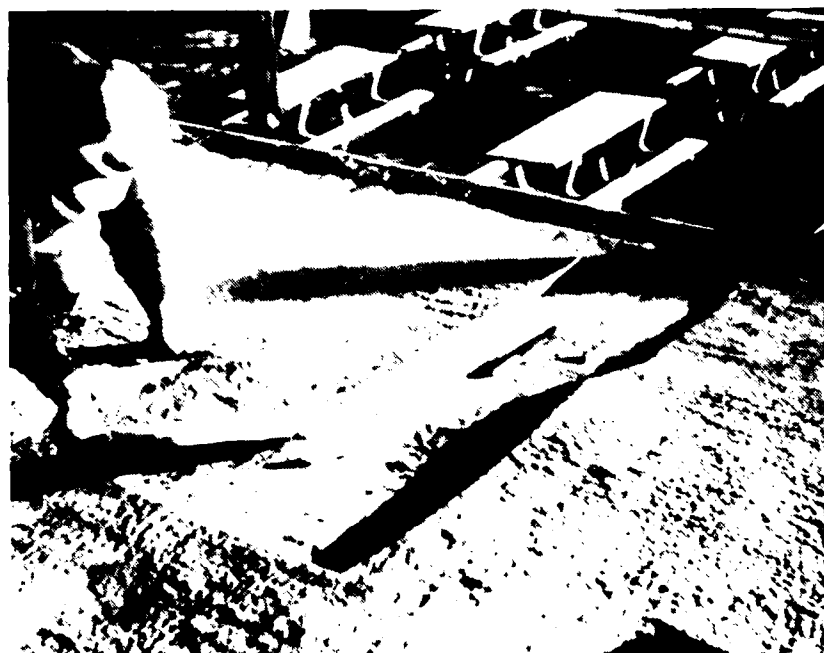
When the old roof was torn off, the insulation was attached to a poured gypsum concrete roof deck rather than gypsum plank. Because of this, the SAM was adhered directly to the poured gypsum concrete and the foam stop rather than the gypsum plank and the foam stop (Figure 3). The western portion of the gypsum concrete deck was subjected to an unexpected rain storm after the BUR was removed and before the SAM was attached. This caused substantial leaking and wetting of the gypsum concrete. The SAM did not adhere well to the gypsum concrete in one area because it was damp. Figure 4 shows a workman removing the SAM (with PUF attached) from the gypsum concrete in the area before the repairs.

Figure 4. Workman remove PUF and SAM from damp area of Galley's roof where SAM did not adhere to gypsum concrete fill. Naval Facility, Cape Hatteras N.C.

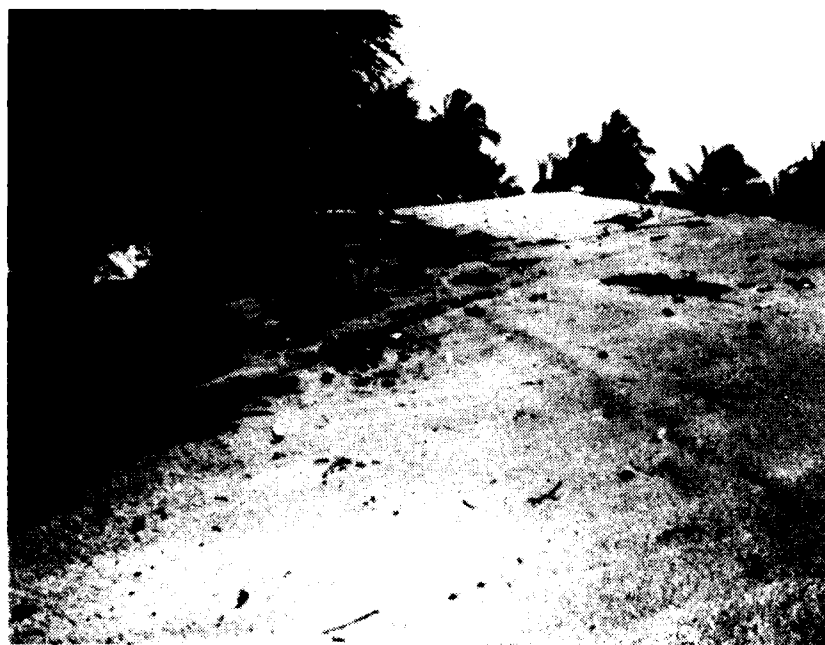
Figure 11. System 2 - Silicone with fungicidal granules. In good condition despite accumulation of leaves and tree limb erosion. Naval Station, Roosevelt Roads, P.R.

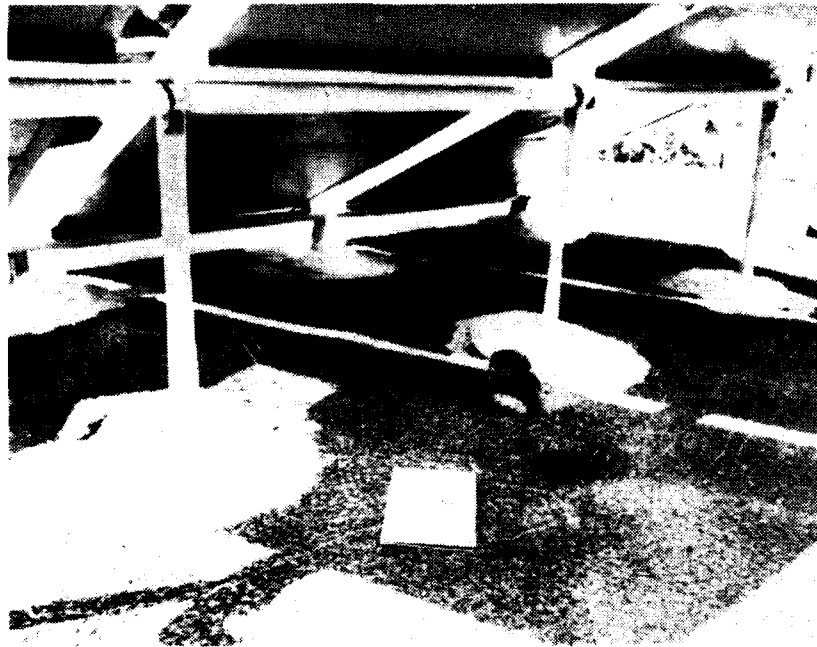
Physical abuse of the silicone coatings was more severe than with the acrylic systems. Palm tree abrasion, such as that shown in Figure 12, occurred on 10 of the 21 roofs, again somewhat higher than with the acrylics. Bird pecking, although not a serious problem, was observed on six of the units. The silicone-coated PUF flashing seals around legs of solar collector supports were in excellent condition, which again shows that the system will perform very satisfactorily when properly coated (see Figure 15).

Figure 15. System 2 - Silicone with regular granules. Typical PUF flashings coated with heavy coat of silicone are in excellent condition. Naval Station, Roosevelt Roads, P.R.

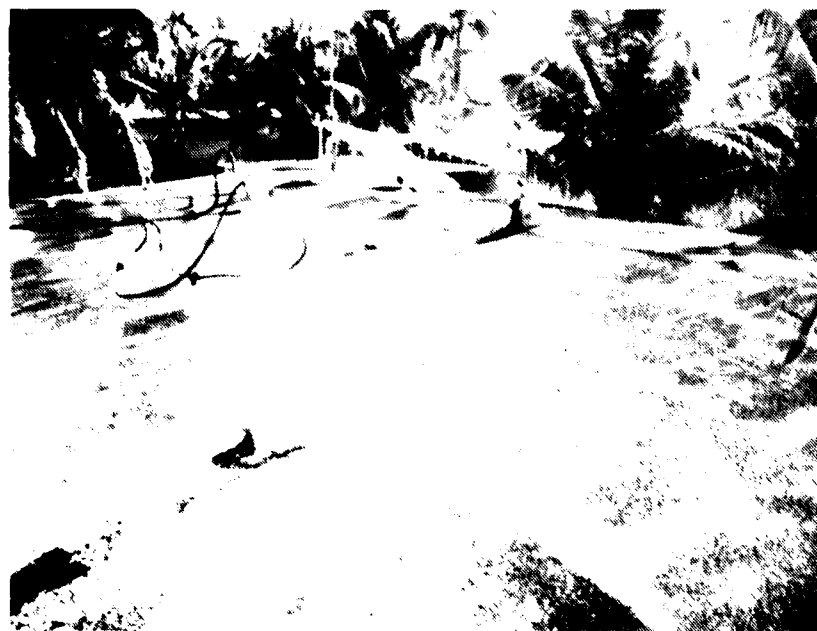
By contrast, most PUF flashings around other vertical projections or penetrations (pedestals for electric service drops, pipes, etc.) were defective as shown in Figures 9, 16, and 17. The foam was not properly applied to form a smooth transition from the roof deck up and around the projections or penetrations. In addition, the rougher foam surface was not coated to a proper dry film thickness to provide adequate protection. The foam around penetrations should be coated with at least two additional coats of elastomeric base coat or with a compatible caulking compound in order to protect the PUF from weathering. This was done around the angles of the solar units but not around the other penetrations or projections.

Figure 16. System 2 - Silicone with regular granules. Poor performance due to coating being applied too thin. Note pedestal for incoming electrical service and loss of granules because of inadequate coating thickness and improper granule embedment. Naval Station, Roosevelt Roads, P.R.

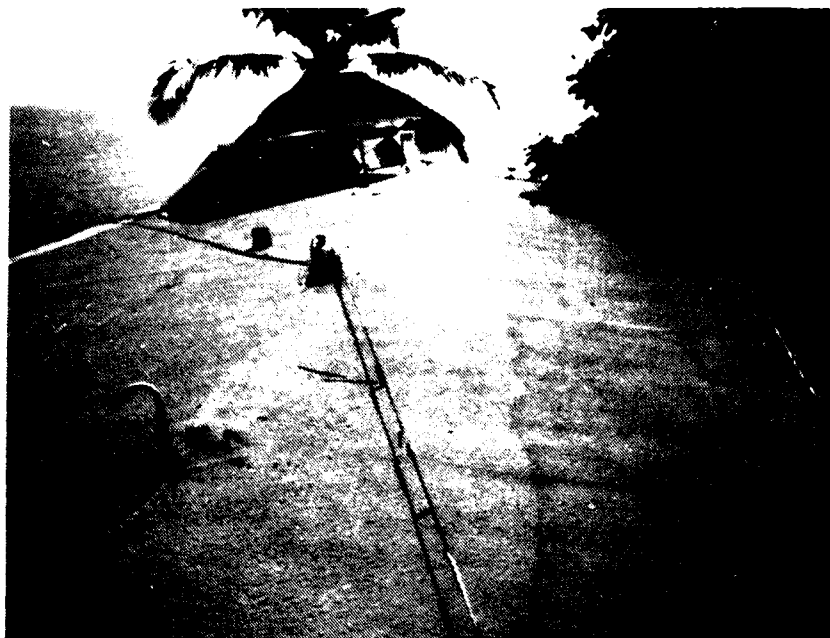
Figure 19. System 1 - Acrylic elastomer with fungicidal granules. Condition very good except for punctures near pipe. Note wires laying on or near coated surface. Naval Station, Roosevelt Roads, P.R.
